**City of Miami
Marine Stadium
At
Virginia Key**

Existing Building Condition Assessment

Project No.: F008449.00

July 21st, 2008

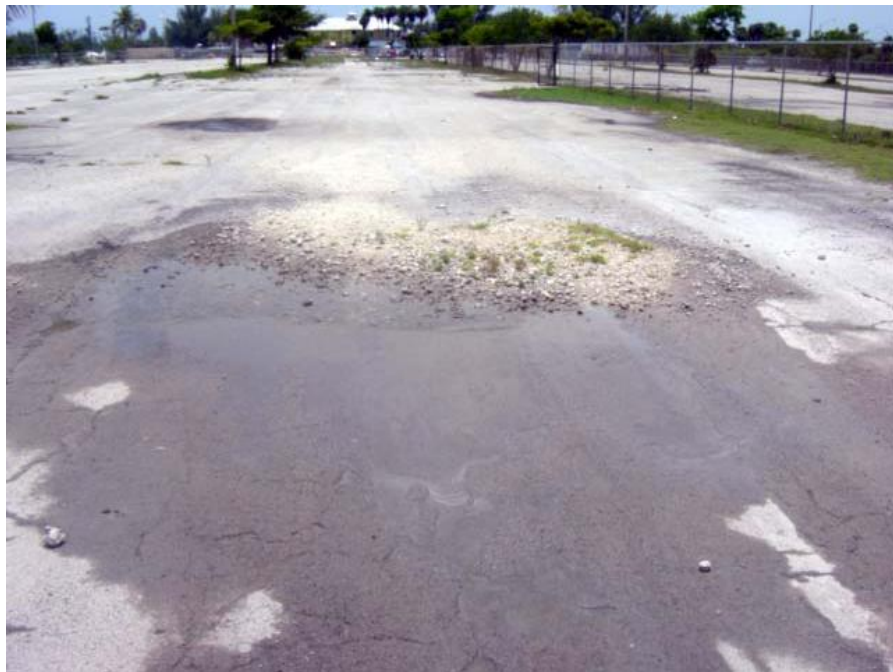
2- Parking Area Paving Deterioration

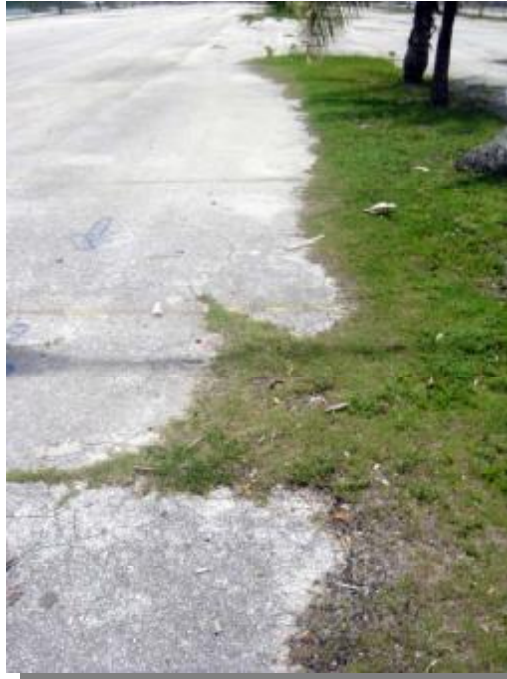
3- Landscape Area Encroaching Into Parking Area

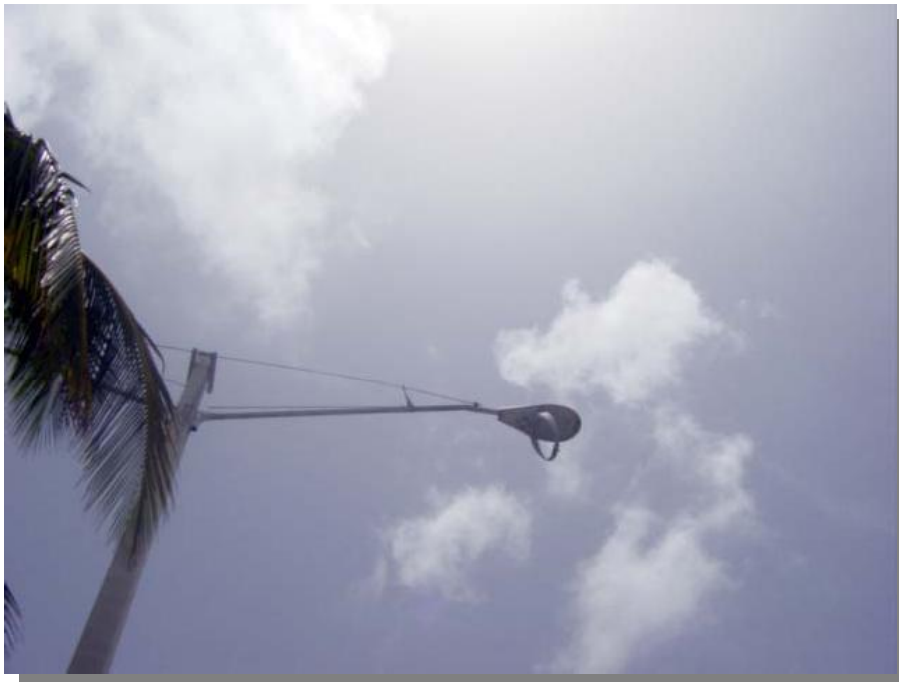
4- Site Lighting Typical Condition

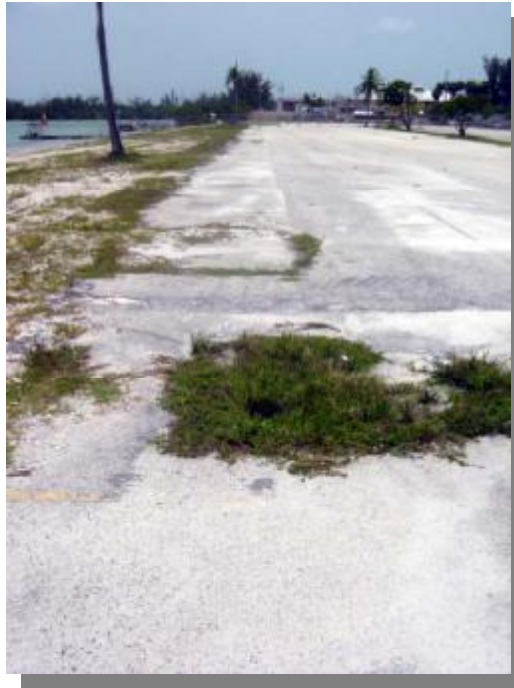
5- Parking Area Deterioration

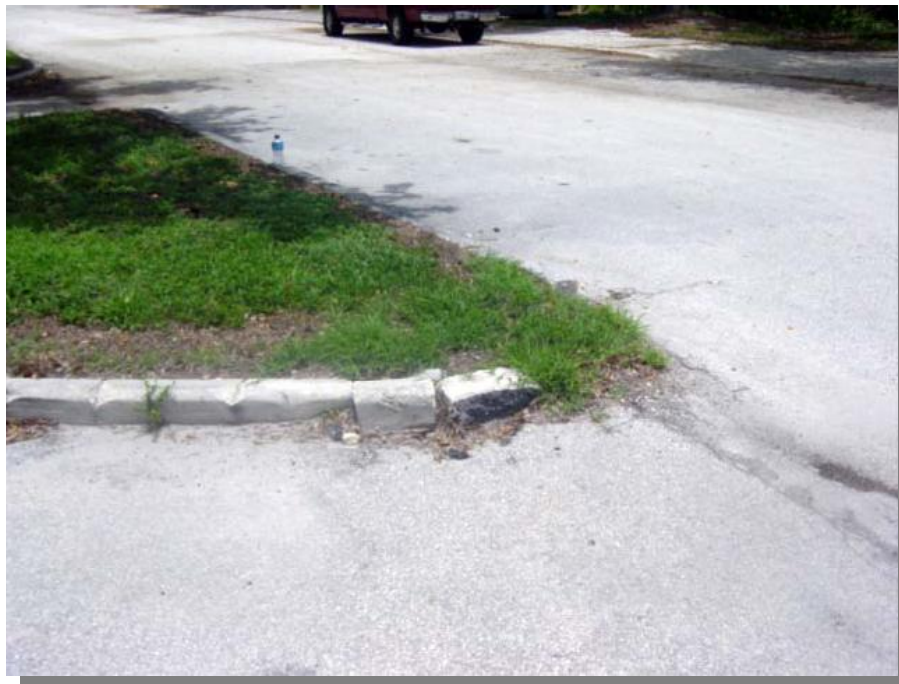
6- Typical Condition of Site Curbing

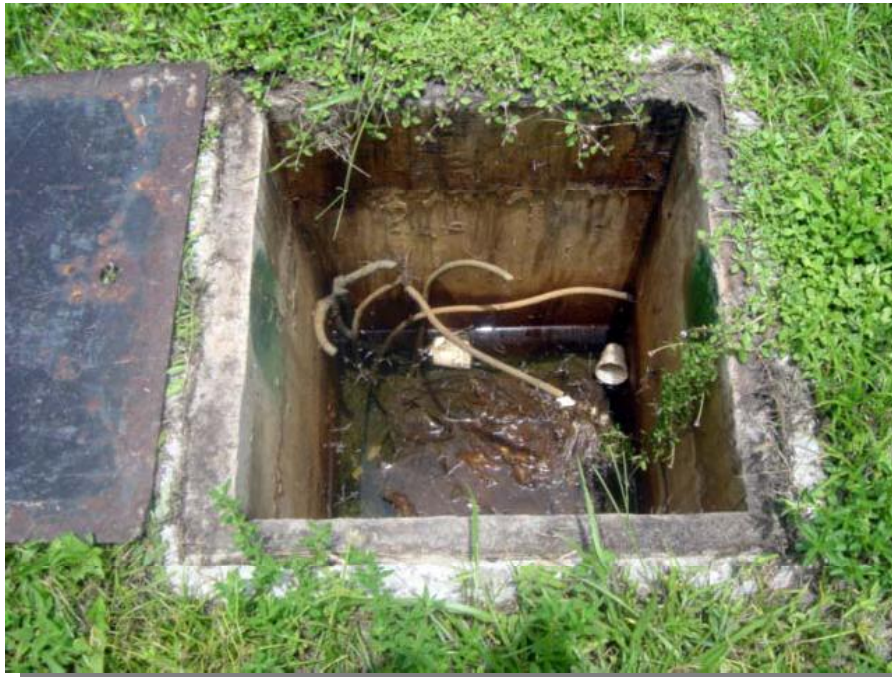
7- Equipment Box Equipment Stolen

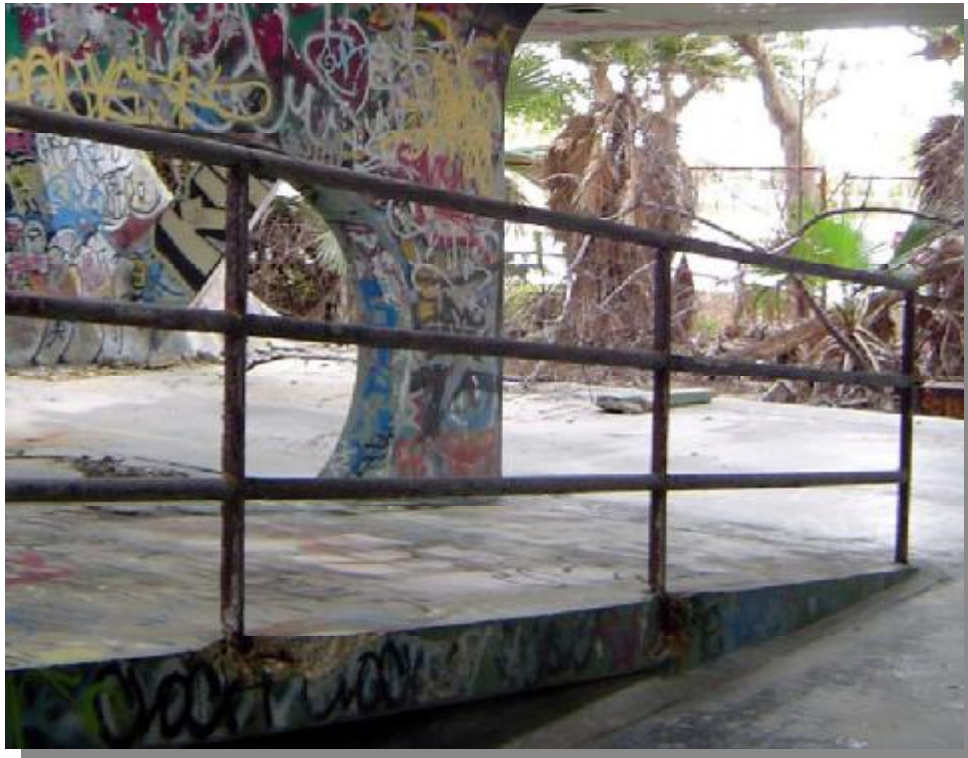
12- Railing and Imbed Condition

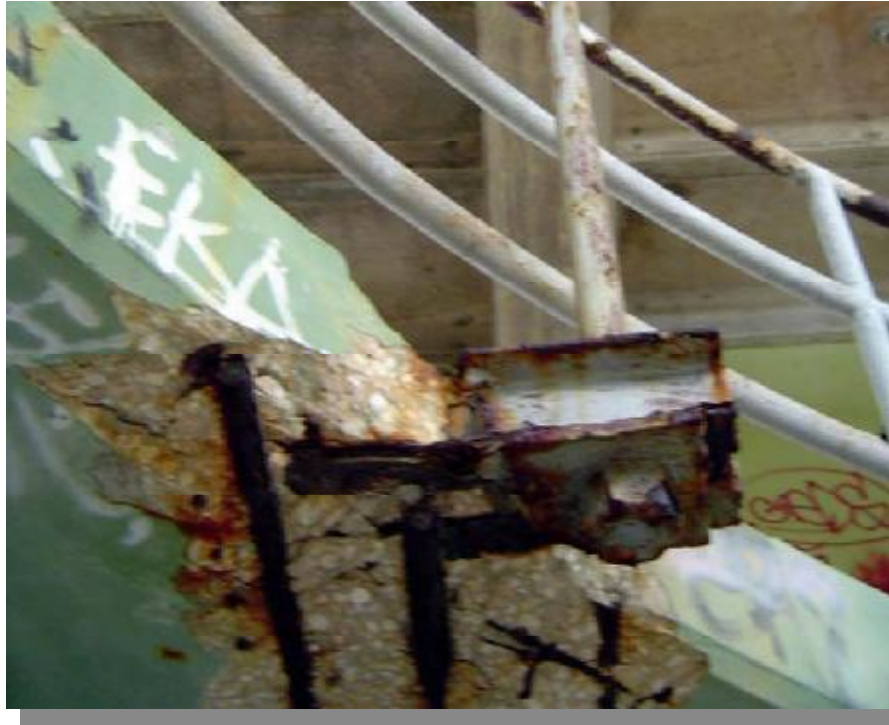
15- Imbed Spalling

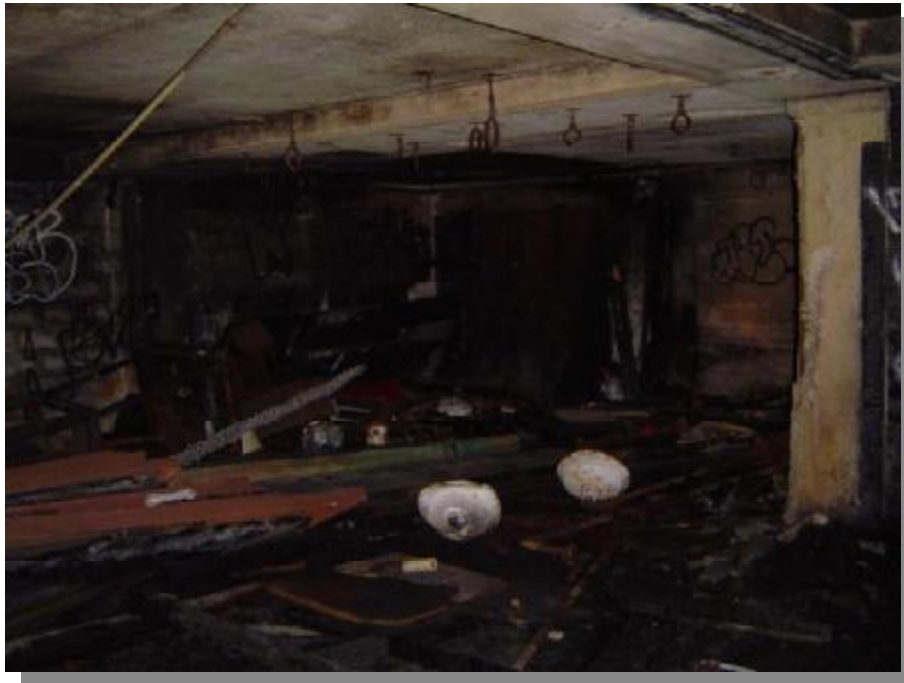
18- Area with Fire Damage

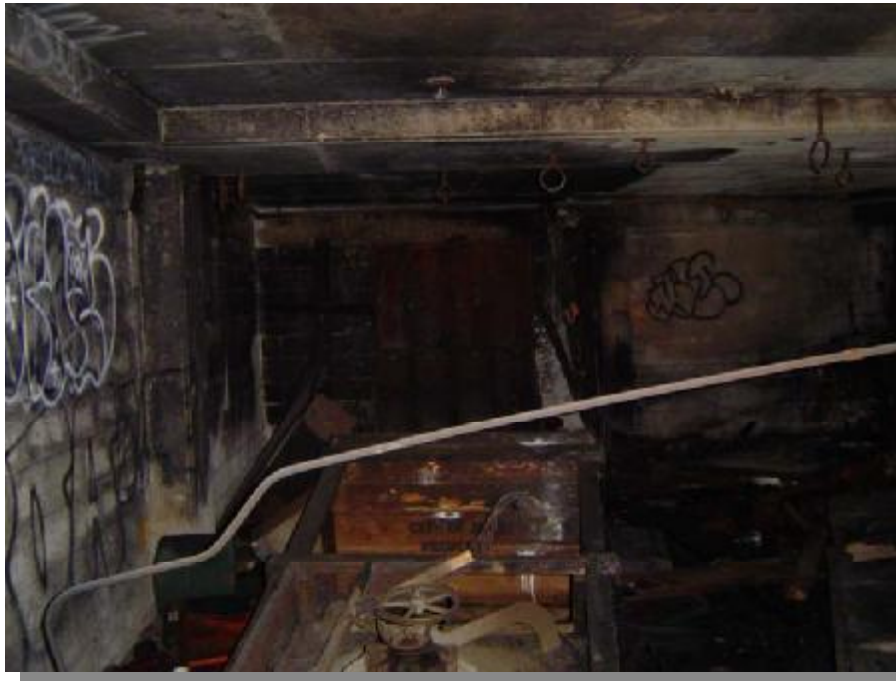
19- Area with Fire Damage

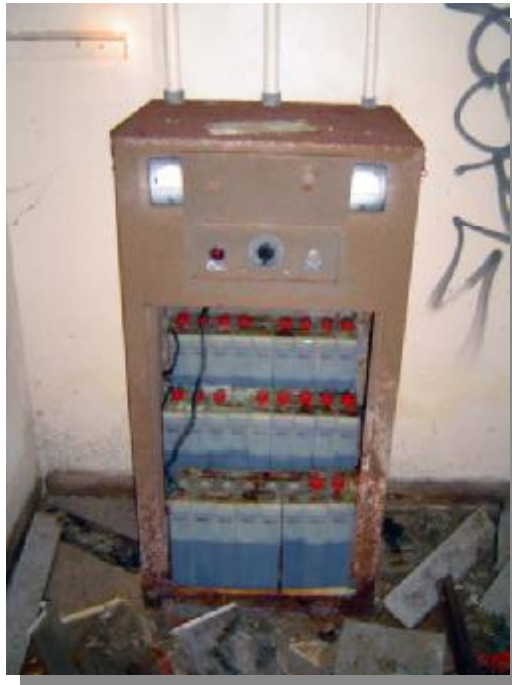
25- Hazardous Material Battery Back Up System

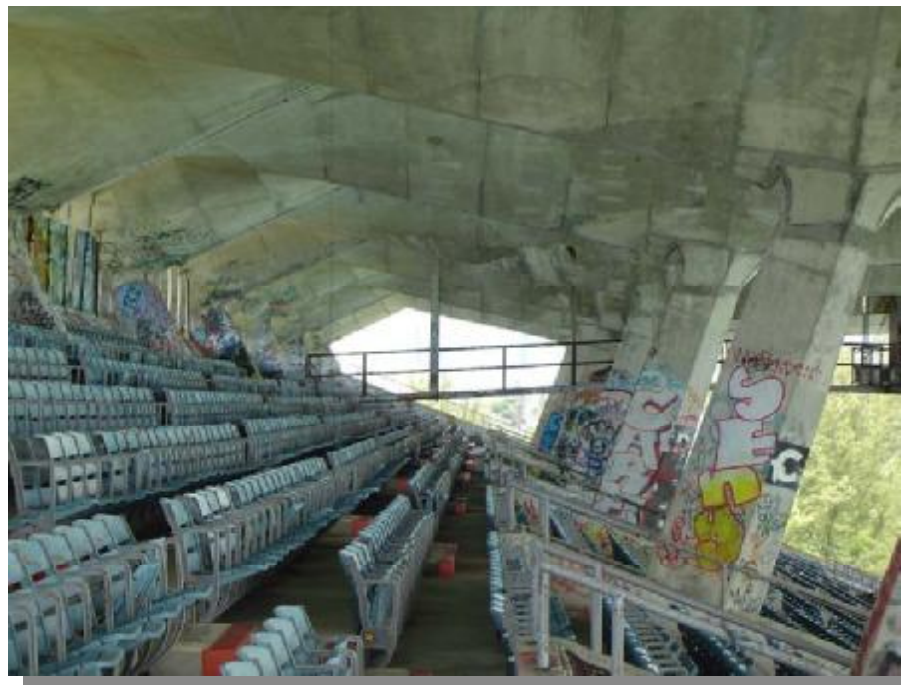
30- Typical Condition Grand Stand Seating Area

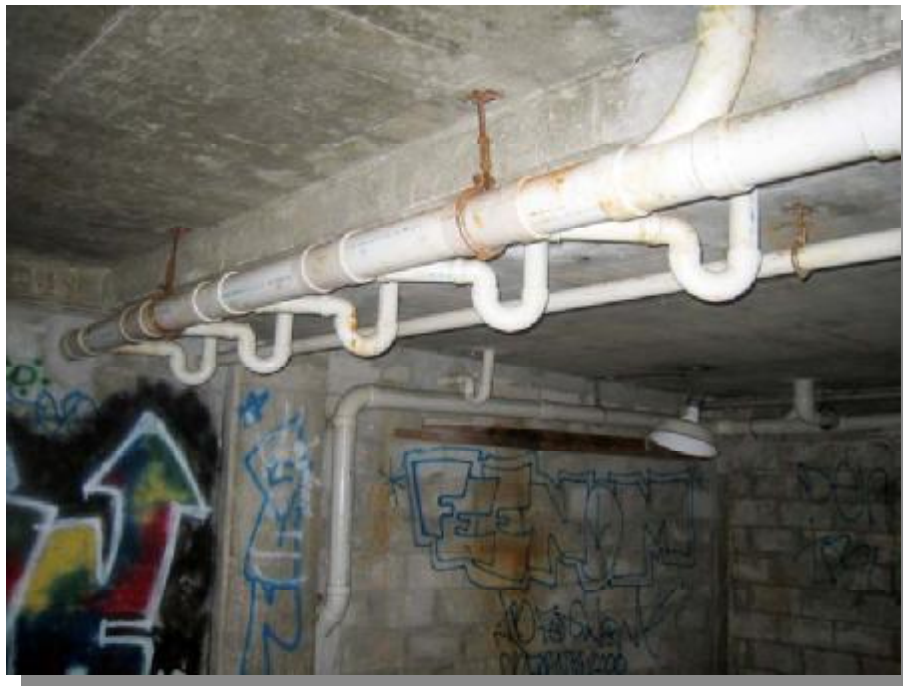
appear to be in poor condition, exhibiting severe surface corrosion. Supports for the sanitary piping have corroded and in some cases failed, leaving sections of the sanitary piping unsupported. Due to the fact that the existing water service to the building is not functioning, leak testing/pressure testing cannot be performed. The sanitary system is not functioning due in part to the fact that the lift station located on the south side of the facility has been vandalized and components required for its operation have been stolen. Also, trash and debris have migrated into the system from open drain lines. Most of the existing fixtures in the restroom areas have been vandalized or stolen. The remaining fixtures do not meet the requirements for handicap accessibility. Sections of the potable water system were observed. The areas that were observed are steel pipe and appear to be severely rusted. The hot water side of the potable water system is insulated and the condition of this piping could not be observed. The water heater located on the first floor mechanical space is rusted due to the location of its installation and also has been vandalized. It should be assumed that because of the period of the construction of the existing facility, the insulation installed on the hot water piping would most likely contain asbestos and would need to be abated.

34- Sanitary Piping PVC Retro Fit and Missing Pipe Supports

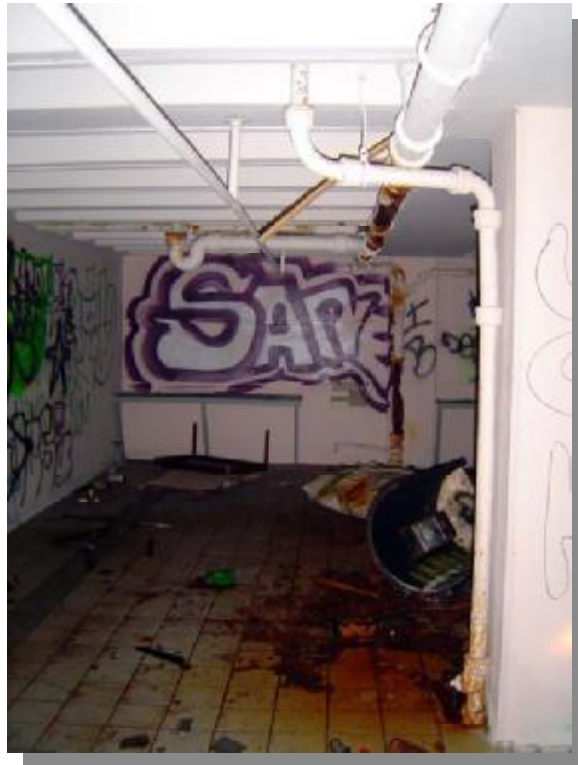
37- Cast Iron Sanitary Line Deterioration

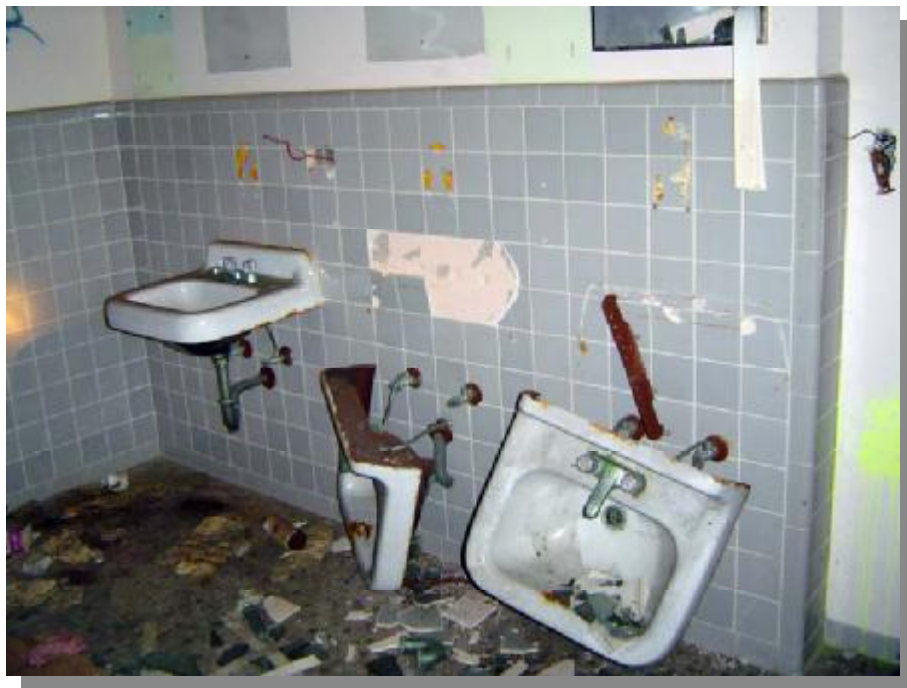
38- Plumbing Fixture Damage

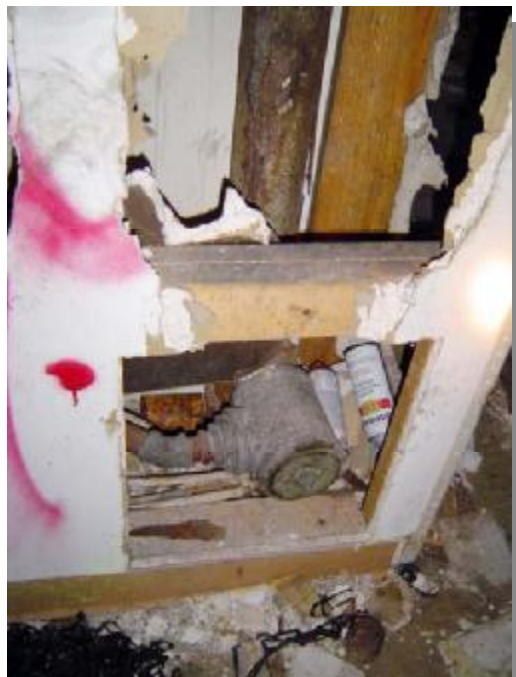
40- Cast Iron Sanitary Piping Deterioration

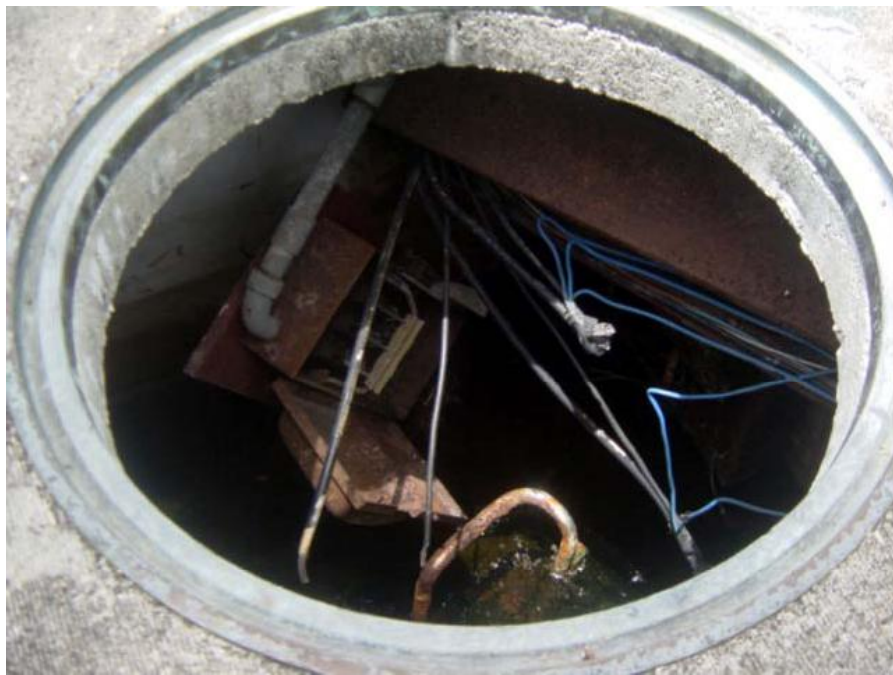
50- Lift Station Equipment Damage

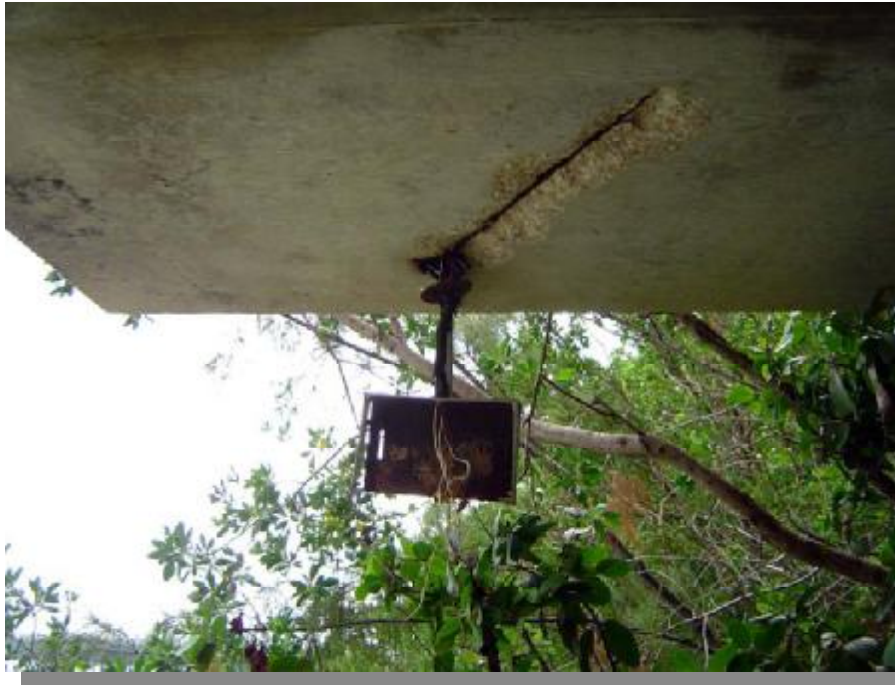
Salt water and salt laden air have infiltrated the raceways and corroded the conduits from the interior. A significant amount of the electrical raceways is encapsulated in the concrete structure and is also causing areas of damage to the existing concrete structure.

51- Conduit and Fixture Deterioration

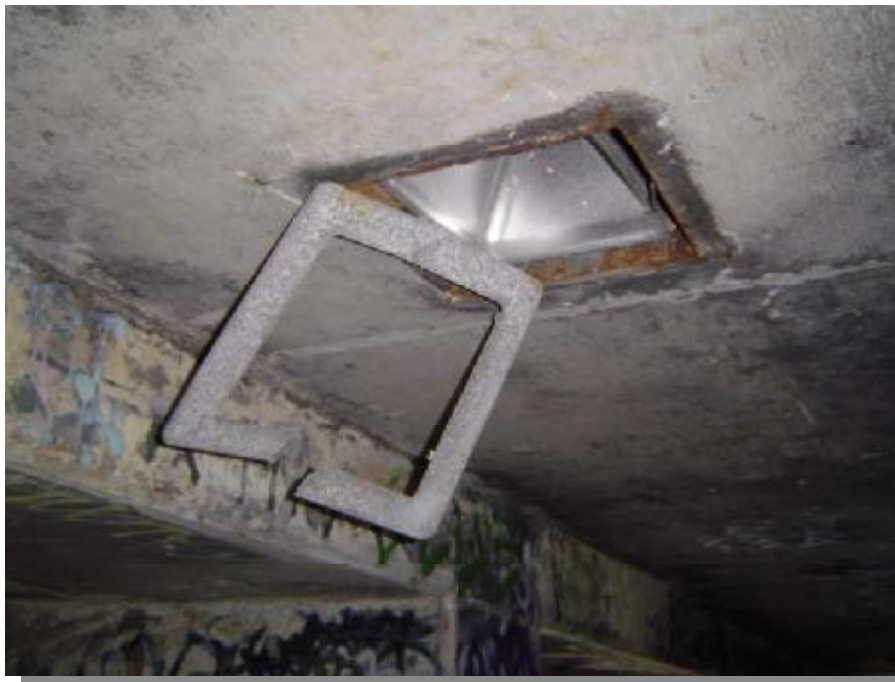
The remaining few lighting fixtures existing have been vandalized or have deteriorated due to exposure and cannot be reused.

52- Fixture Deterioration

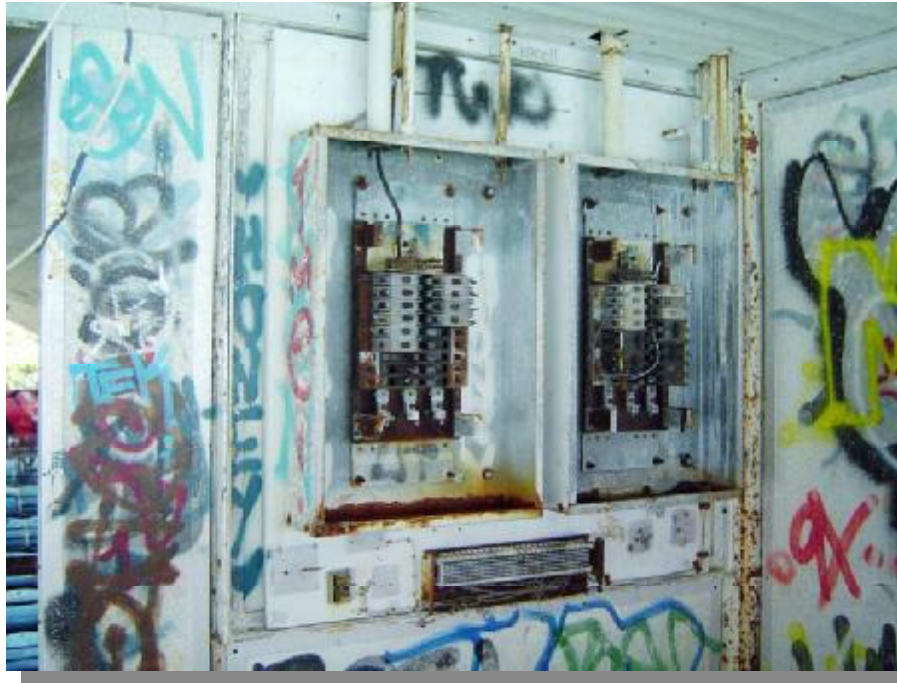
The existing electrical panels were observed to be in very poor condition and the majority of the internal components of the electrical distribution system have been stolen or disassembled. The remaining electrical cabinets and raceways have been corroded due to the proximity of the equipment to the salt air and also several storm events.

57- Disassembled and Deteriorated Electrical Panels

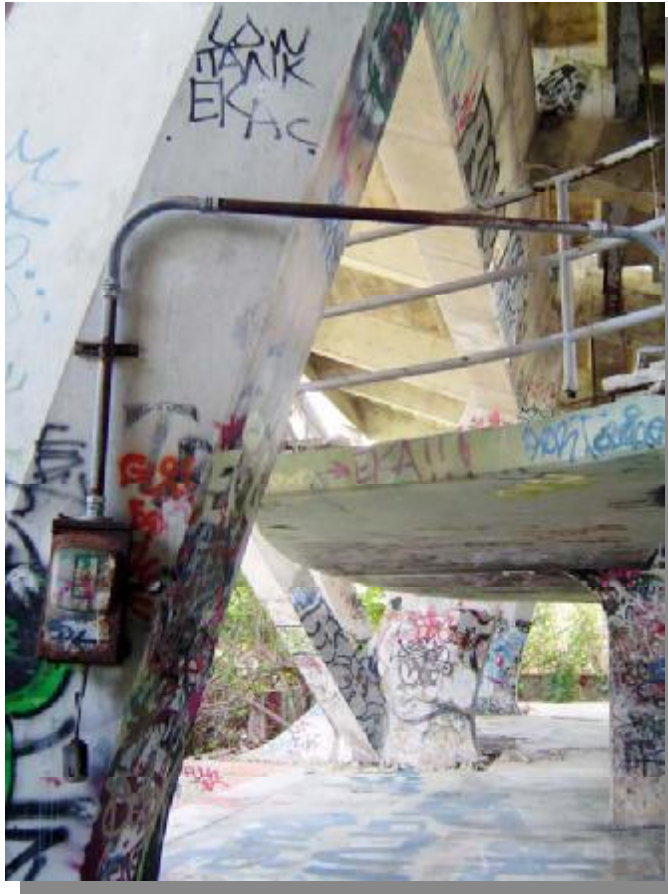
59- Electrical Disconnect Typical Deterioration

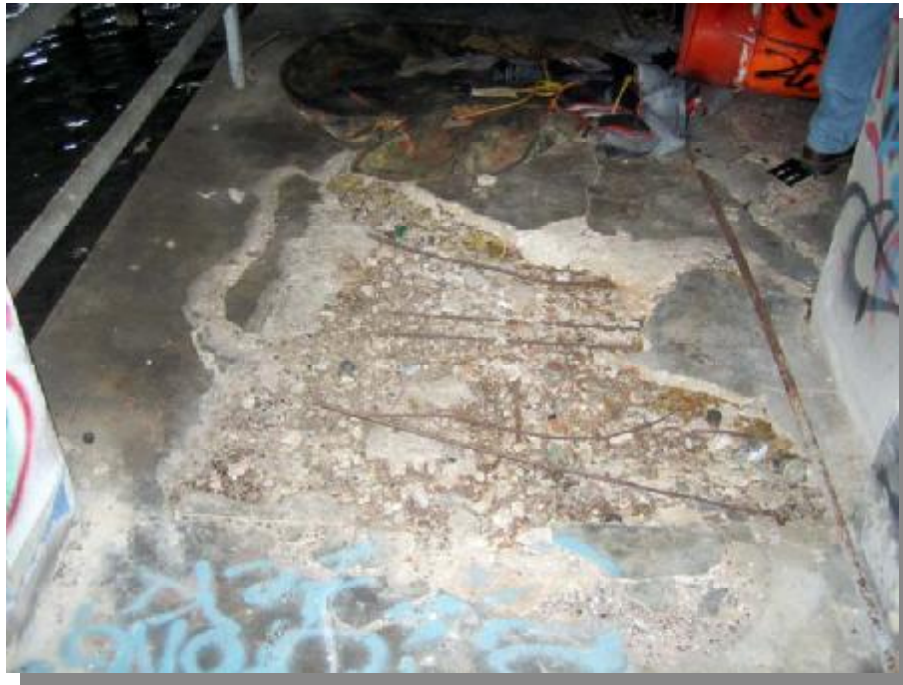
60- Lower Level Walkway Slab Deterioration

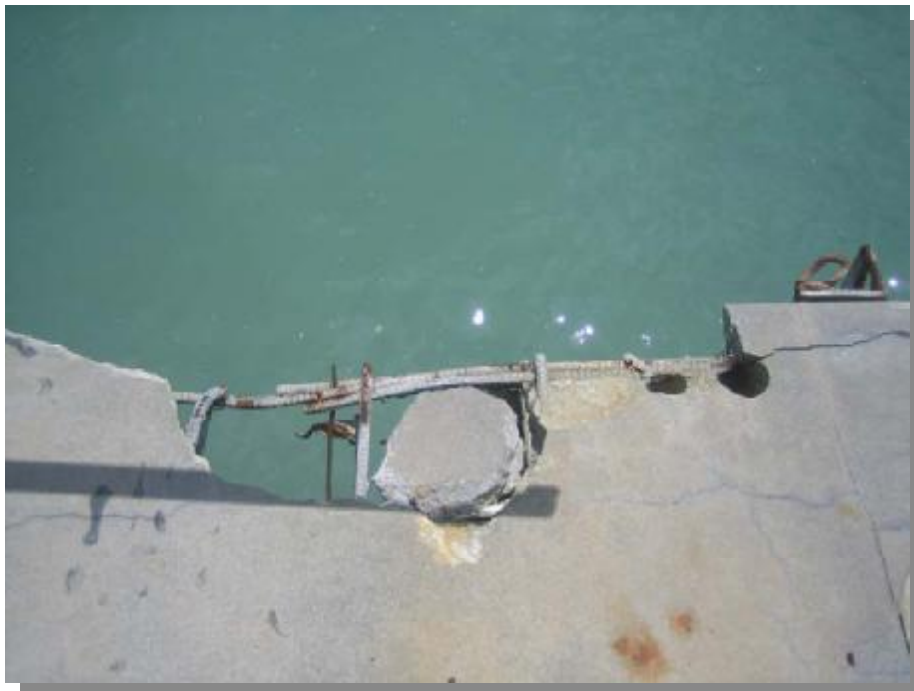
61- Lower Level Slab Deterioration

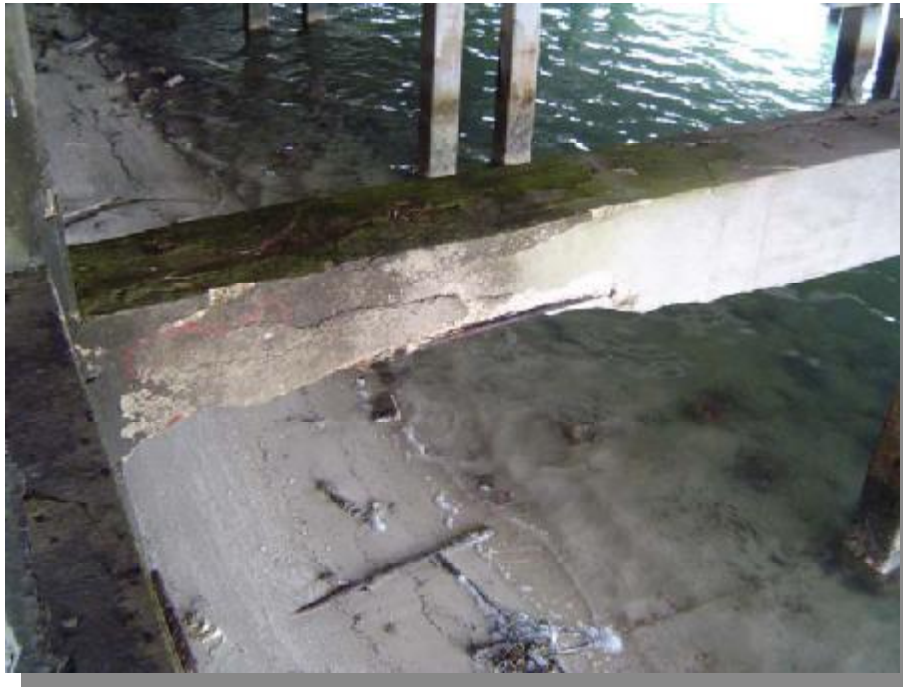
62- Concrete Beam Damage

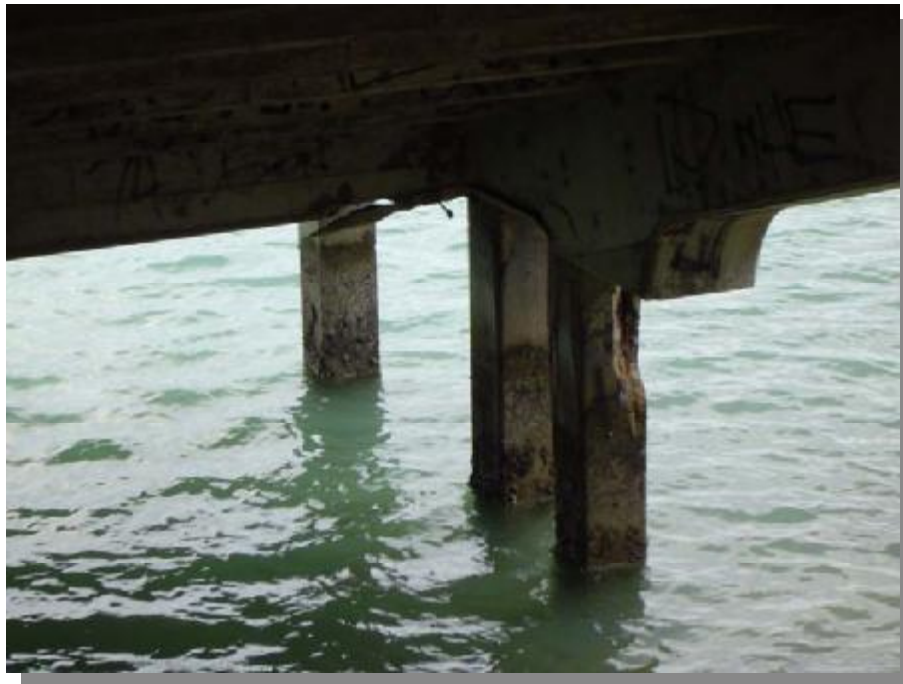
63- Column and Beam Damage

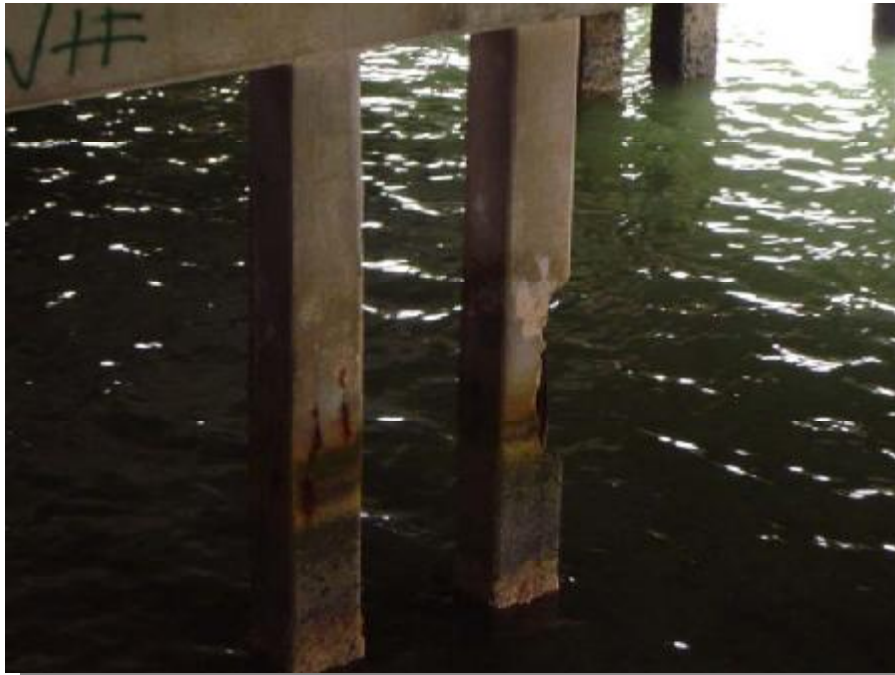
64- Column Damage

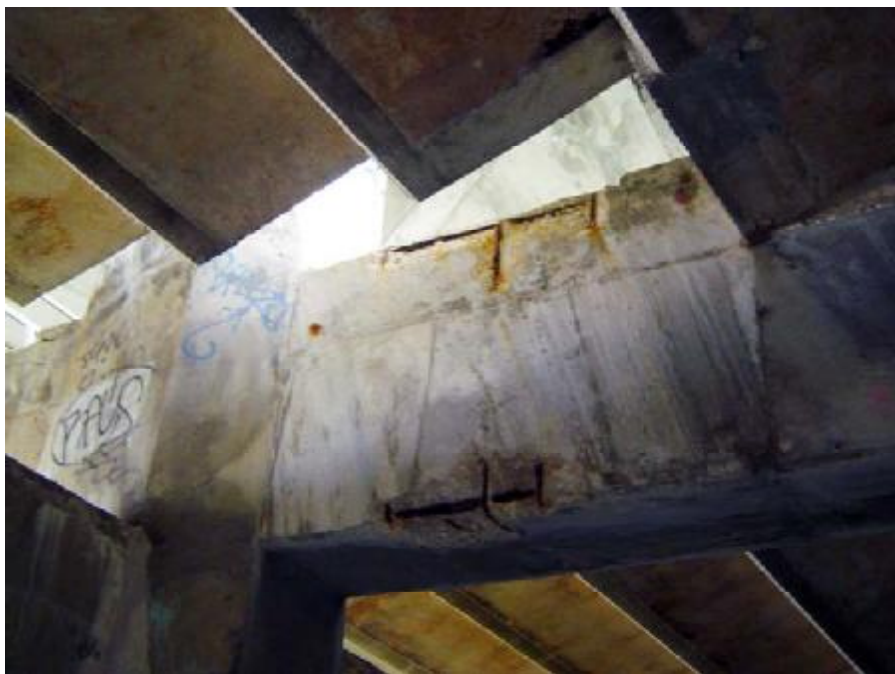
65- Main Support Beam Deterioration

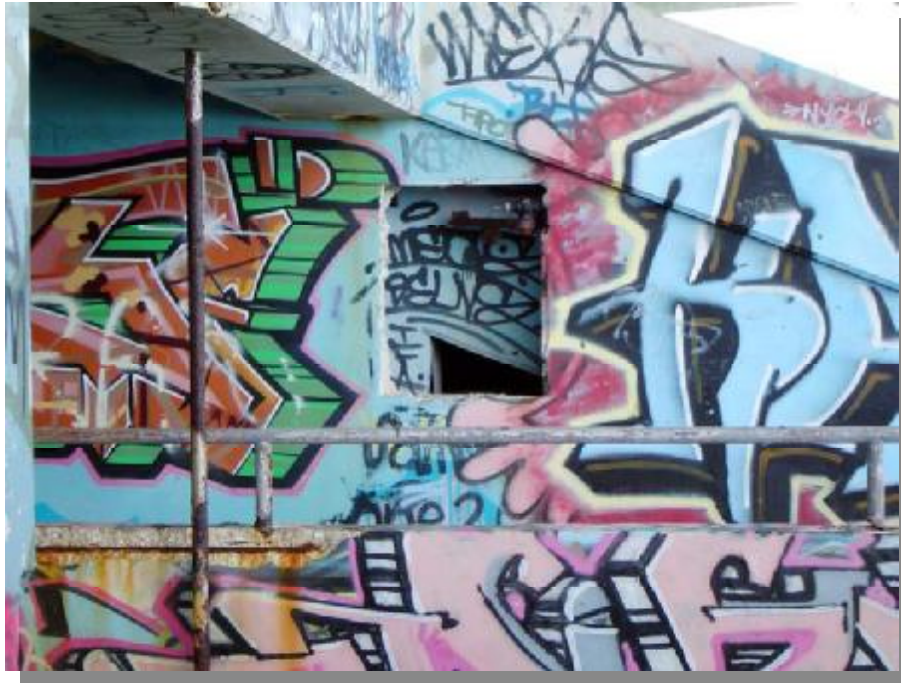
66- Main Ramp Support Beam Deterioration

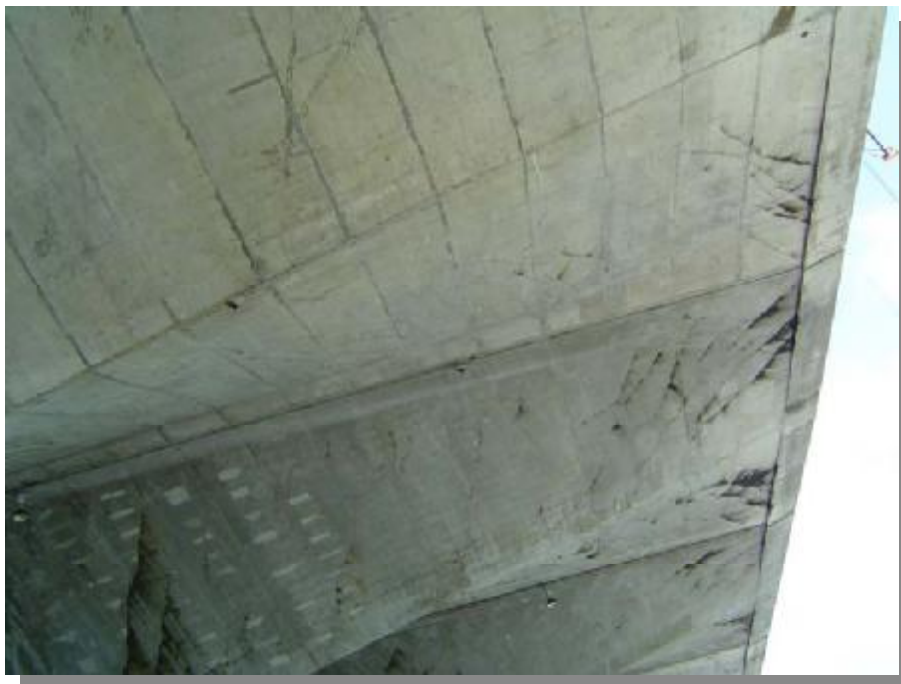
67- Over Head Concrete Structure with Water Seepage

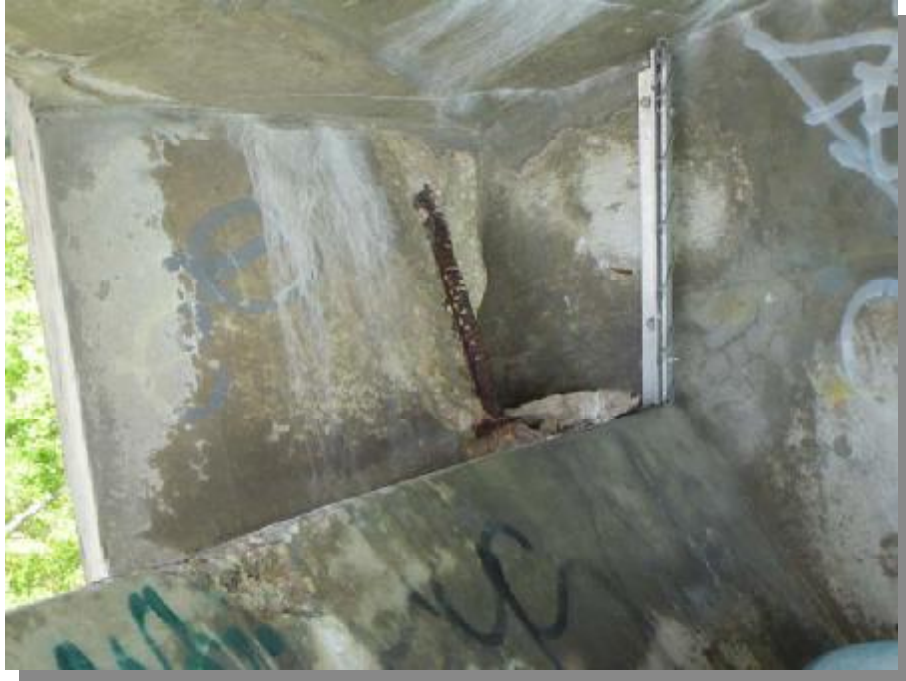
68- Main Column Deterioration

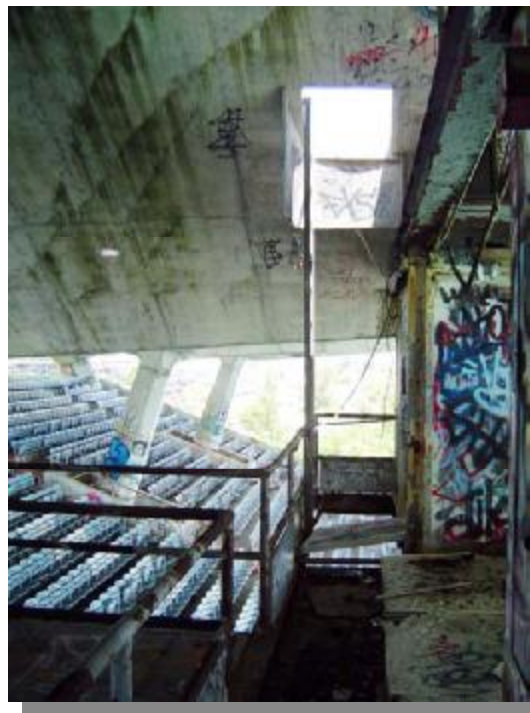
code for handicap accessibility and portions would need to be reconfigured if the seating was able to be reused. The control booth area structure, during several site observations, was found to be in very poor condition. All lighting and sound equipment was deteriorated or vandalized and no equipment was found that could be reused.

71- Control Booth Structure Deterioration

It is recommended that due to the condition of the control booth area, the City of Miami should take immediate action to have the access way removed in order to keep anyone from wandering into this area as sections of the floor system have rusted through and fallen.

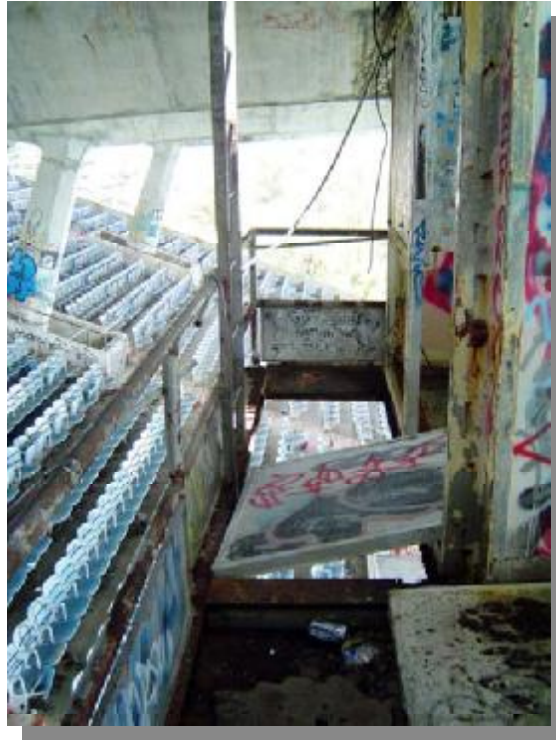
72- Control Booth Structure Deterioration

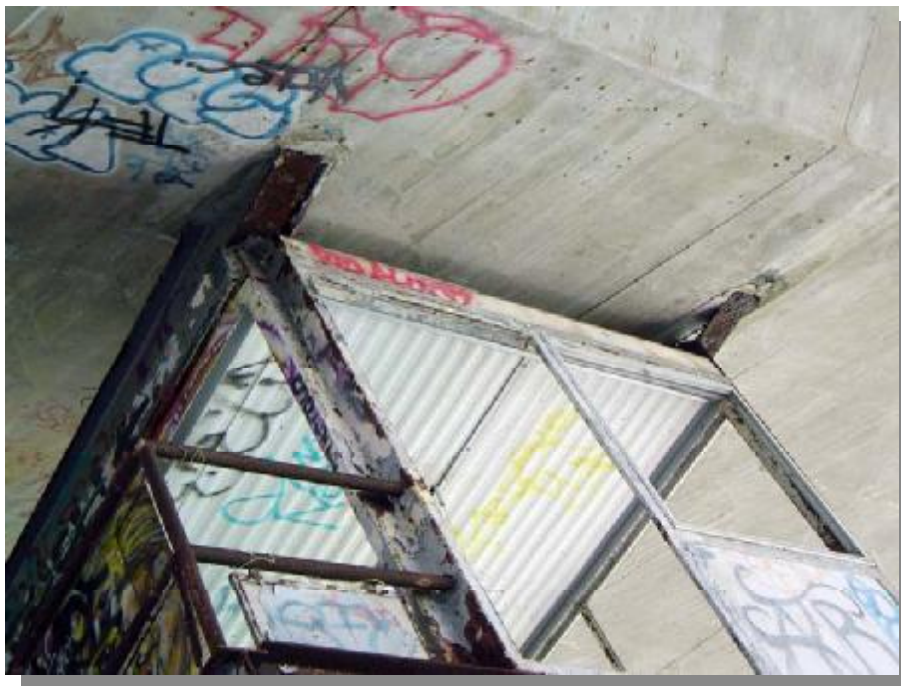
Dressing Rooms have spalled, exposing the rusted steel reinforcement. The steel structure supporting the overhead control booth and the access bridge are severely corroded and unstable. The mezzanine concrete slab shows several cracks while the supporting steel connections and posts that hold the slab are severely corroded. There are numerous cracks in the cantilever concrete roof slab which need immediate repair. Most of the roof drains are clogged allowing rain water to collect and seep through the concrete cracks. Numerous diagonal columns, which hold the cantilevered roof structure, show corrosion signs and require repair. A thorough structural analysis will be required to determine if the roof structure meets the requirements for High-Velocity Hurricane Zones of chapter 16 (Structural Design) of the latest revision of the 2004 Florida Building Code. Additional information on the structure's conditions is provided in the Bliss & Nyitray evaluation report.

73- Control Booth Support Structure Deterioration

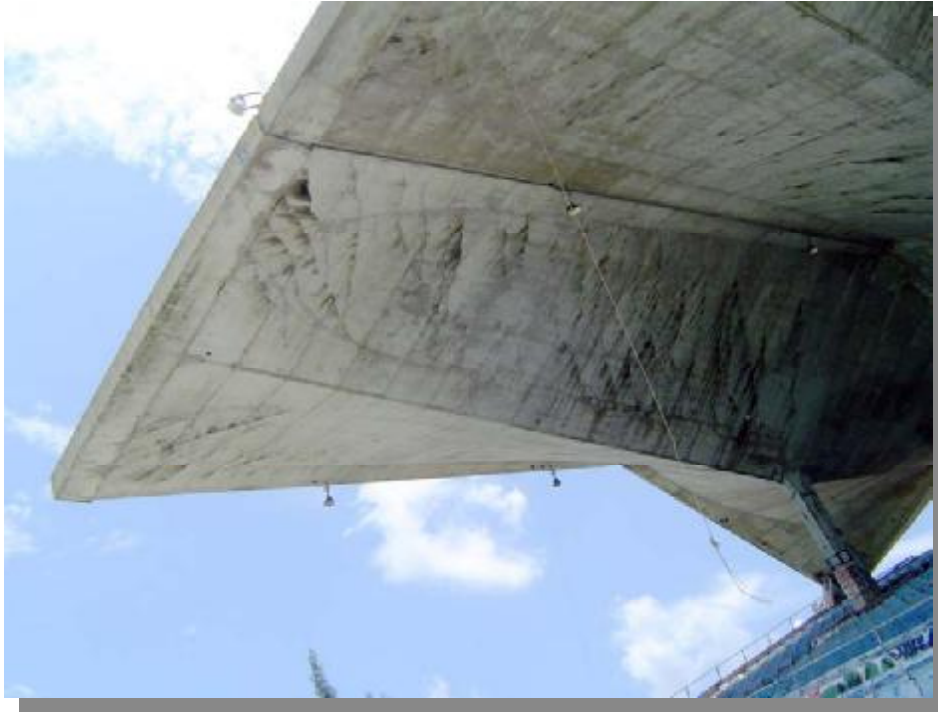
74- Over Head Concrete Structure with Water Seepage
